## Metallurgical Failure Analysis

### Plywood Press Roller Bearing Failure Analysis

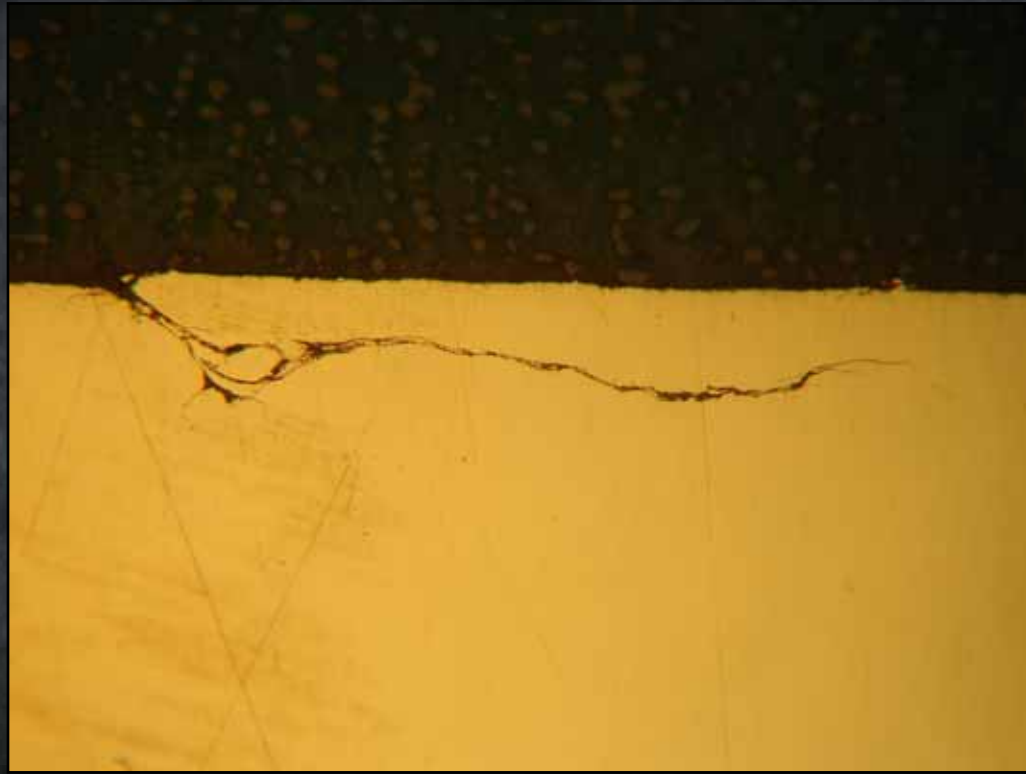
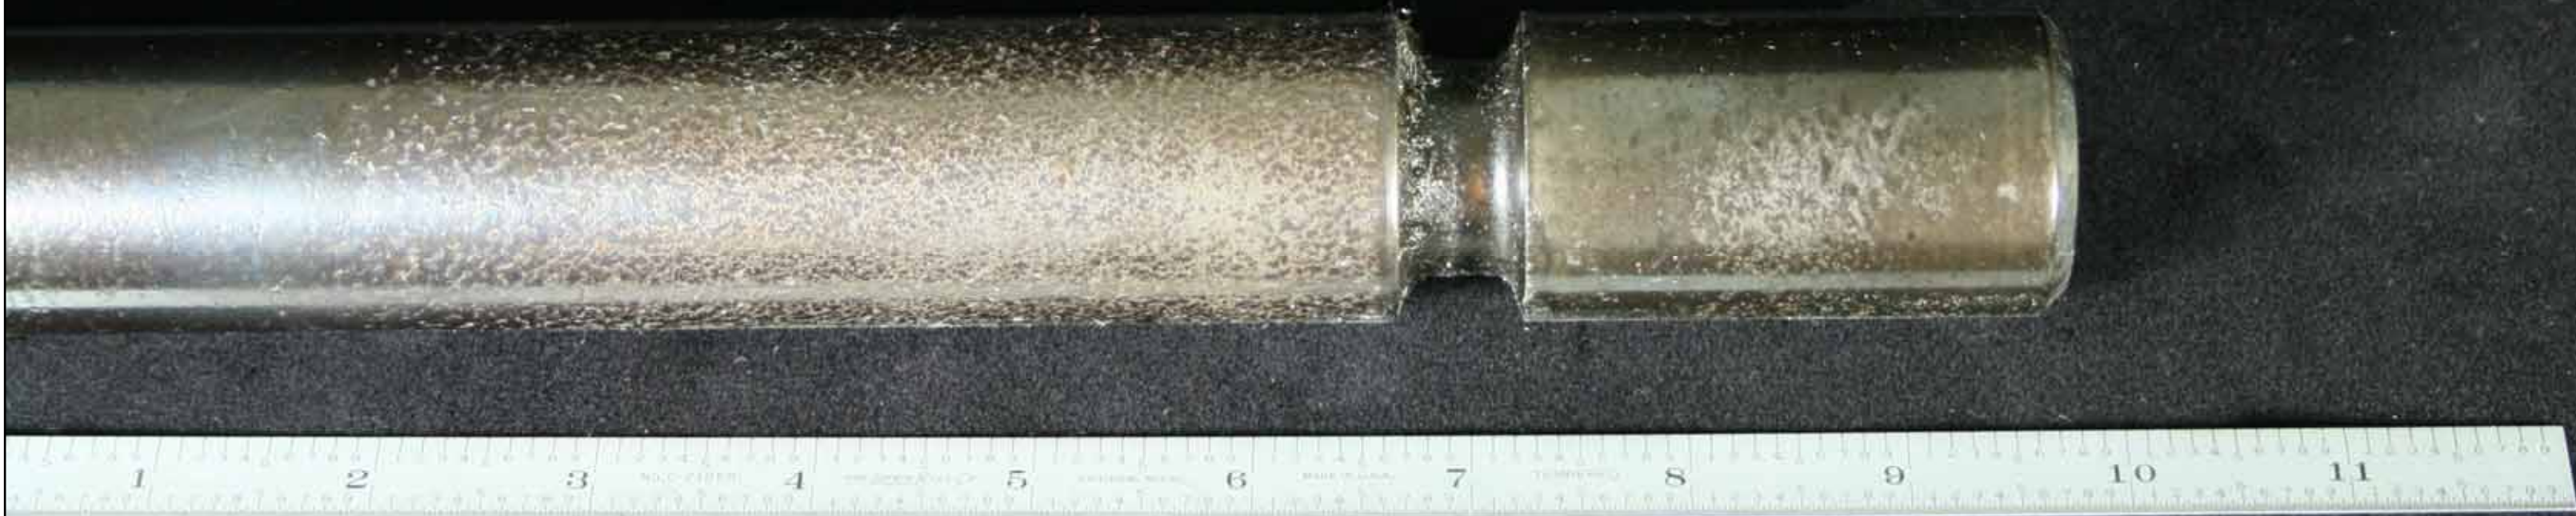
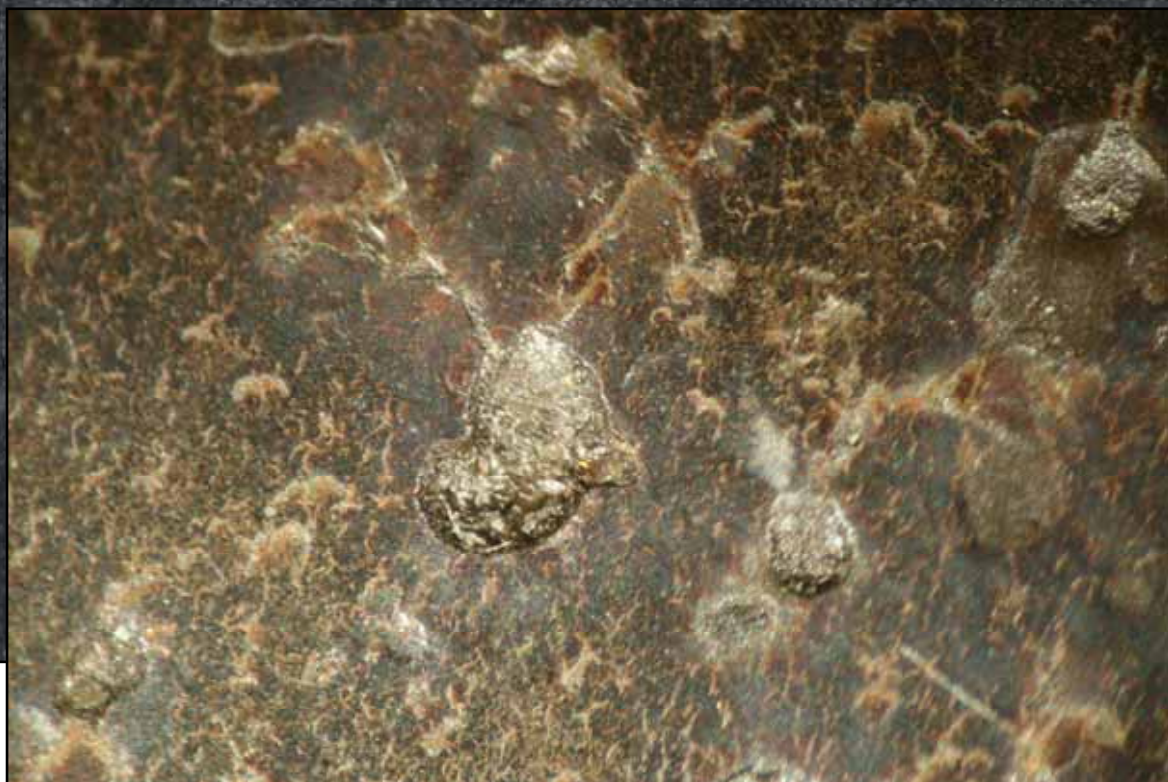
All of the rollers exhibited a "pitted" surface in the region of contact with the product. Metallurgical analysis of the press rolls, along with chemical analysis of press components and associated debris determined that the press rolls were failing by Rolling Contact Fatigue (RCF).

Rolling contact fatigue is a well known failure mechanism typified by shallow subsurface cracking which propagates largely parallel to the rolling surface. This phenomenon is caused by the high shear stresses that are developed just below the surface in Hertz contact regions.

Alterations to operating conditions can be used to control or alleviate RCF.
